STATIC and DYNAMIC EARTHQUAKE TESTING
of RAINSCREEN STUCCO SYSTEMS
for
BRITISH COLUMBIA RESIDENTIAL
WOOD FRAME CONSTRUCTION

November 2002
(Revised June 2003)

Prepared by:
G.W. Taylor, H.G.L. Prion, C.E. Ventura and M. Kharrazi

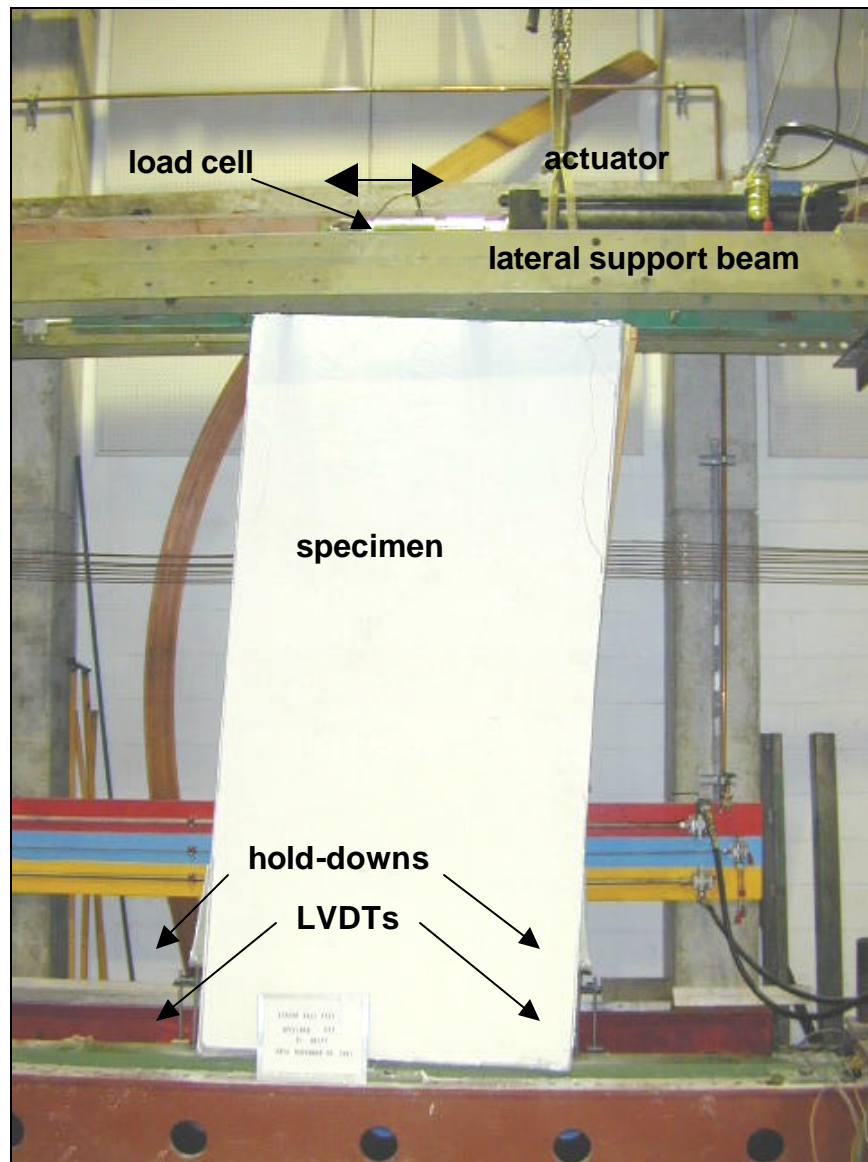
Fig. 1. Static test on stucco shear wall panel

The equipment used to perform the reverse cyclic static testing of the stucco test panels is illustrated in Appendix B. Features of the static test setup are as follows:

- (1) All test panels were 2438 mm (8'0") in height.
- (2) Each test panel was secured against sliding and overturning by anchor bolts and hold-downs respectively.
- (3) Actuator and load cell have a 550 kN capacity and a 600 mm stroke.
- (4) All test data was electronically recorded.

- (5) Recorded test data included resistance at top of panel, lateral deformation or drift at top of panel and uplift at each holdown.

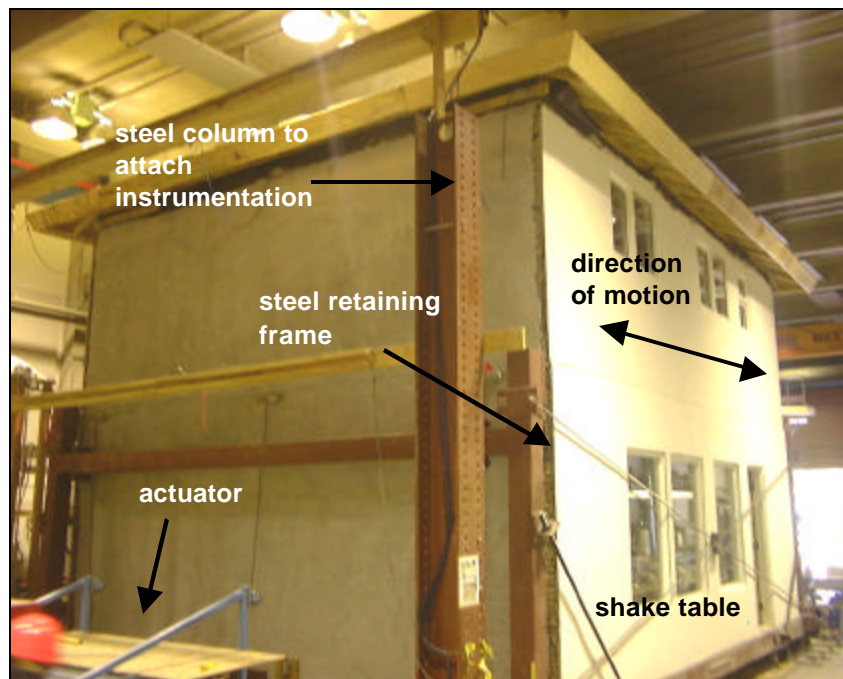
Fig. 2. Dynamic shake table test of two-storey single-family woodframe house with stucco

The test setup for the dynamic tests comprises a horizontal steel frame supported on low friction rollers that permit uni-directional motion. The steel frame acts as the foundation for the two storey test house. The steel frame is driven by a high capacity actuator mounted on the plan centreline of the frame. The actuator has a peak capacity of 300 kN and a maximum stroke of 1000 mm.

A maximum of thirty-two channels of test data were recorded electronically for each test. The primary data recorded for each test included actuator force, steel frame displacement and acceleration, first storey drift and acceleration (location of upper floor) and roof drift and acceleration.

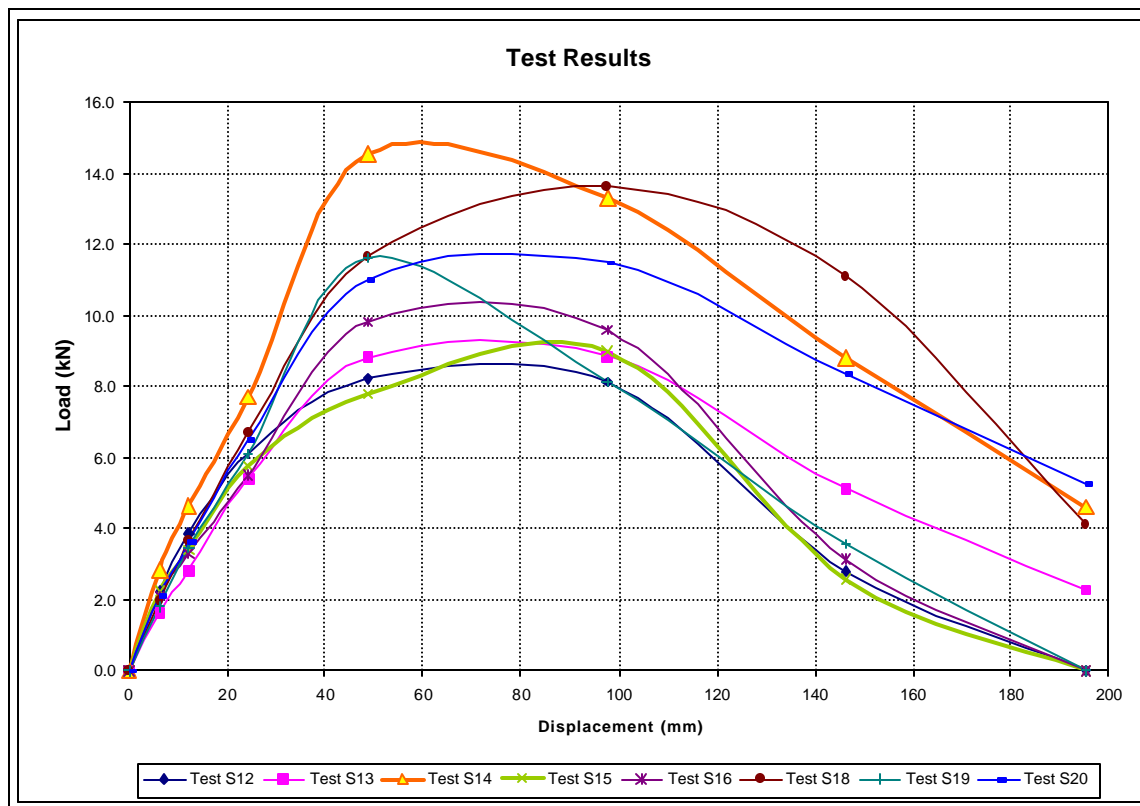
Series 1 Static Envelope Curves

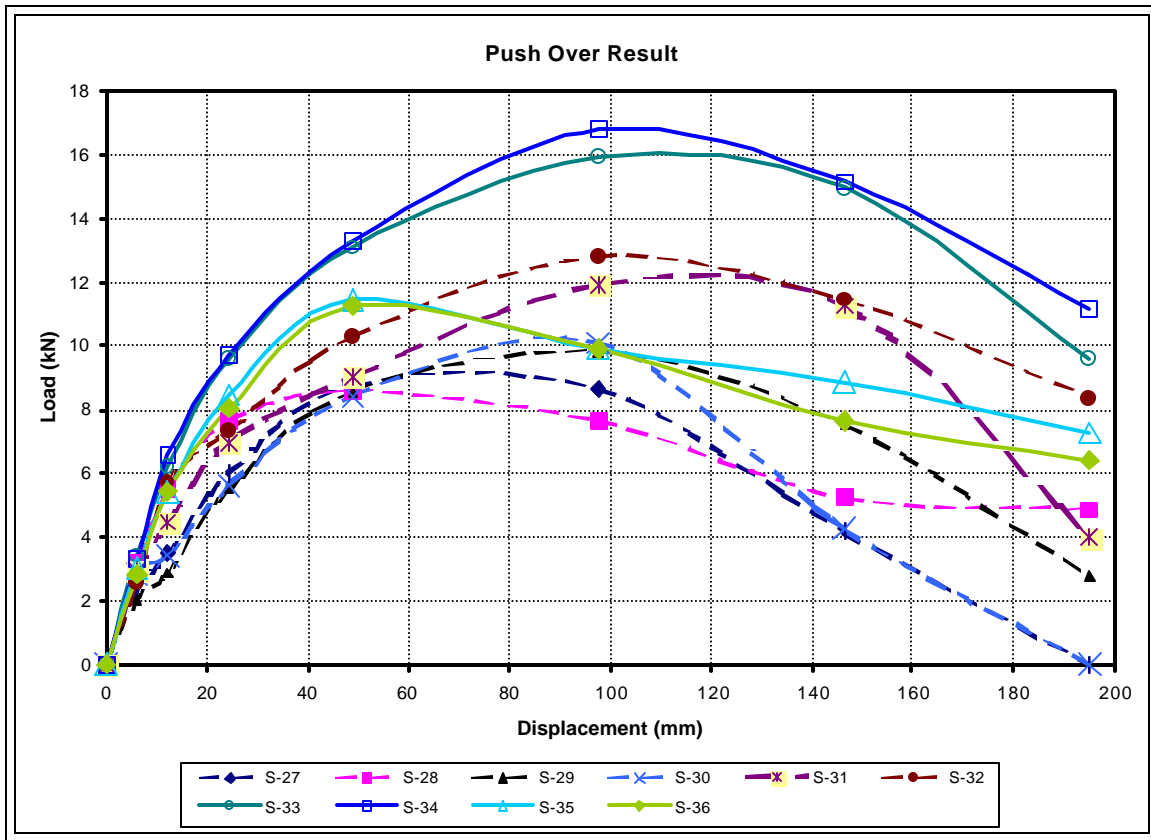
Series 2 Static Envelope Curves
